### CERCLA to act as guideline during MMRP investigation

# MMRP field work begins this spring

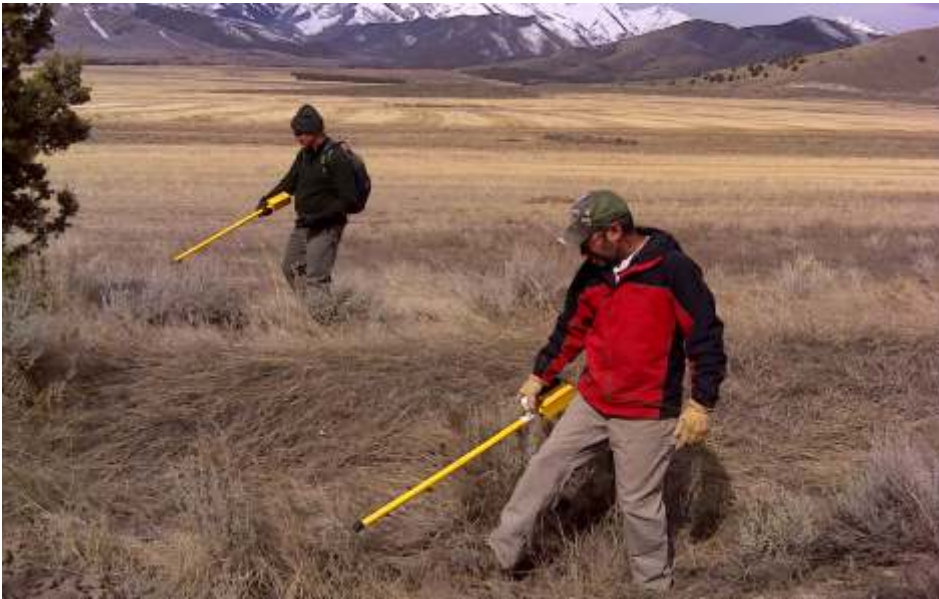
Contractors use hand-held magnetometers to detect metal anomalies. These instruments will be used during the investigations taking place this spring.

In April, contractors used hand-held analog magnetometers to help them search the surface for indications of past munitions use while they conducted visual reconnaissance at the Southeast and Southwest Areas. While this equipment is able to identify anomalies, it cannot store data, such as the size or location of anomalies, for future use. Contractors walked predetermined routes to ensure that each site was thoroughly investigated and a recommendation for the site could be made with an acceptable amount

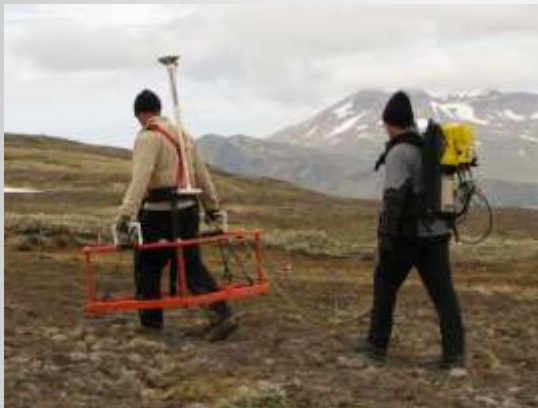
**EM61-Mark2**

The EM61-Mark2 is usually pulled on a cart by a single operator. However, in areas with rocky terrain, like some of those around Camp Williams, this instrument is more effective when “worn” by the operator.

The equipment used during the Remedial Investigation may be more sophisticated than that typically used during a Site Inspection. In addition to hand-held magnetometers, personnel will use Digital Geophysical Mapping (DGM) equipment. This DGM equipment is more sensitive and can measure and record the geophysical signals that result from buried metal objects. “Some DGM equipment is passive, measuring anomalies in the local

magnetic field, and some DGM equipment sends an electromagnetic current into the ground,” said Fitzmayer. “Either way, the resulting geophysical signal is recorded at a rate of approximately once per second as the DGM operator walks over the ground. Each geophysical signal is paired with a location coordinate from a high-precision GPS unit. This way, the location of metal anomalies is recorded, and anomalies can be flagged for follow-up investigation.”

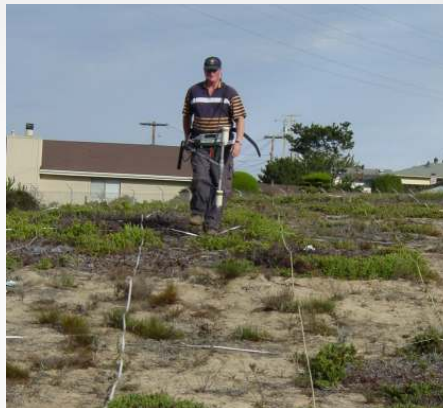
**G-858**

The G-858 pictured above is a type of hand-held magnetometer. Contractors will use this instrument while walking in grids like those pictured above.

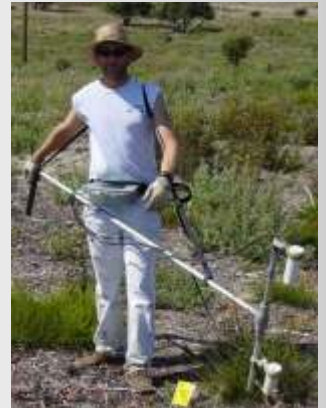
**G-858**

The G-858 can only detect ferrous (iron) metal. In munitions response work, most items of interest contain iron, making this an effective instrument.
